PRODUCT IMPROVEMENT ANALYSIS,
F-4D FIRE CONTROL SYSTEM

January 1971
(Revised October 1972)

Prepared for
OGDEN AIR MATERIEL AREA
Hill Air Force Base, Utah
Under Contract F09603-70-A-2026-QP02

Publication C02-01-1-1094

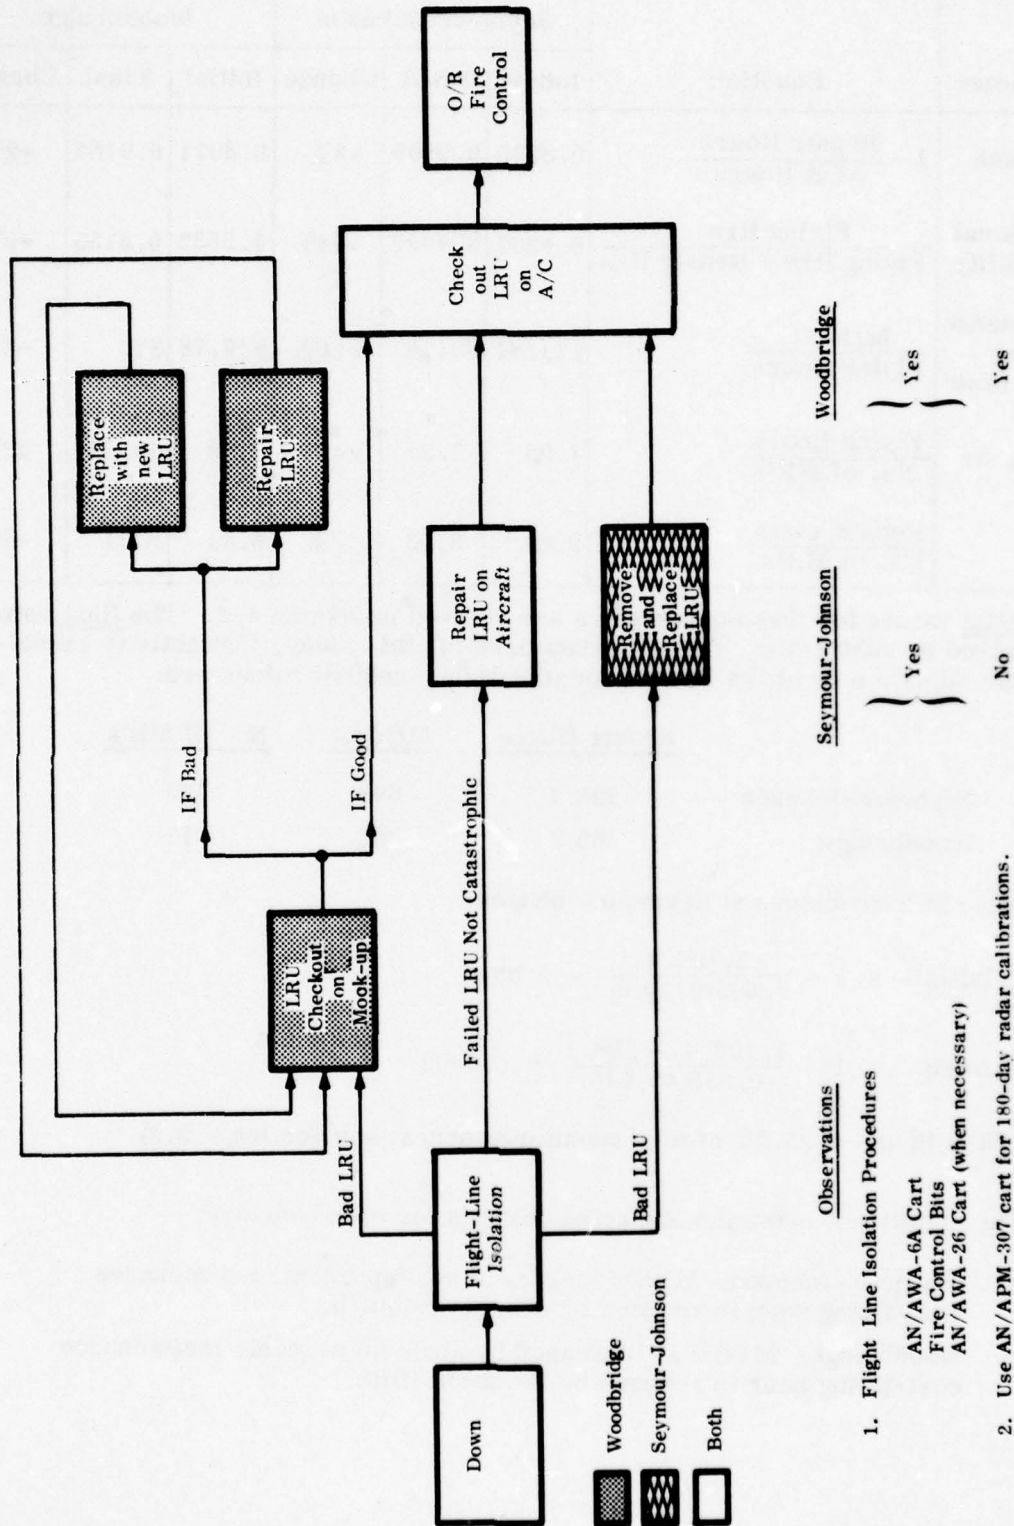
Figure 4-1. Flight-Line FCS Maintenance Procedures at Seymour-Johnson and Woodbridge

Two significantly different flight-line maintenance procedures for the FCS were observed at Seymour-Johnson and Woodbridge. These differences are best described graphically, as is done in Figure 4-1. The significant points are:

- a. Woodbridge uses the AN/APM-307 cart to calibrate the FCS of each aircraft every six months, while Seymour-Johnson uses the AN/AWA-26 cart. The -307 cart energizes, excites, and tests the system in a dynamic state, while the -26 cart is used to align LRU's and test the system in a steady-state condition only. The -26 cart would thus be used to adjust or align any malfunctions detected by the -307 cart.
- b. Before installing any LRU on the aircraft, Woodbridge tests it for system compatibility on the F-4D Fire Control Shop mockup. This assures that system homogeneity is maintained to the highest degree possible.
